Project: Proposed Additions Location: St Josephs School, 77 Wellington Street Northam

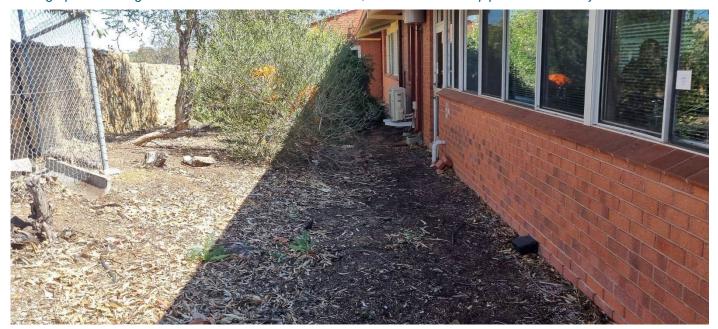
Photograph 7: Facing north-west from near borehole HA02; note half concrete pipe to left from adjacent church site.

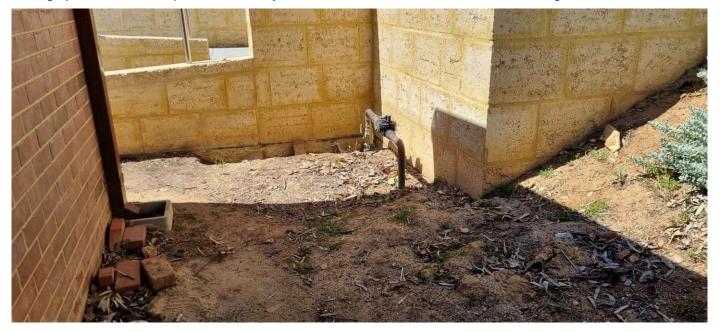
Photograph 8: View of low point of area subject to inundation at south-east corner of building

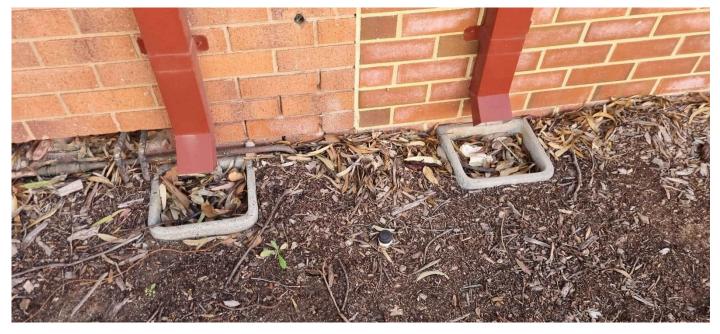
Photograph 9: Downpipes discharging into concrete drain boxes: note leaves clogging drains
