ROAD SAFETY INSPECTION

Spencers Brook Road Slk 3.26 –
23.87

Report Issue Date: **8/06/2018**

Revision 1

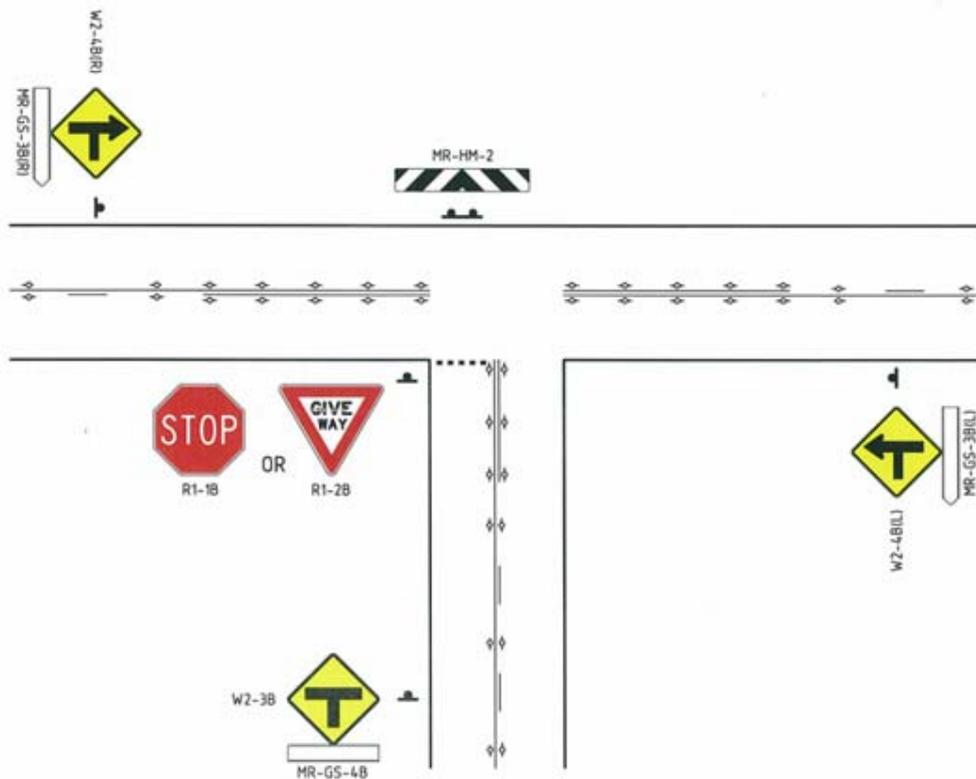
MRWA guideline drawing 201031-0008 shows the recommended typical intersection sign and device installation. It was observed that most intersections within the audit scope do not have the recommended installation of signs and devices.

Install the recommended signs and devices (including RRPM's and holding lines) in accordance with MRWA requirements at all intersections (note use of MR-HM-2).

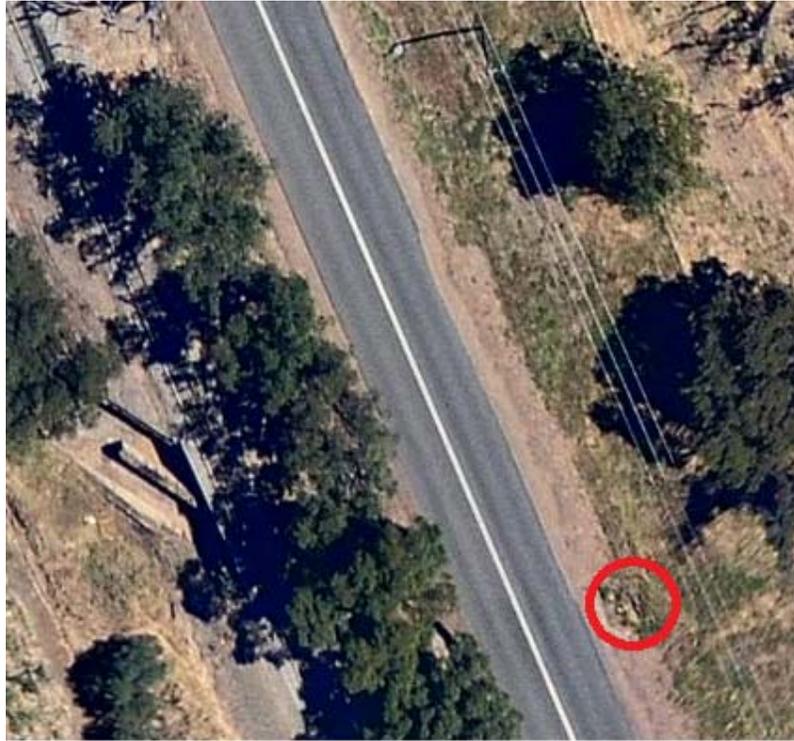
The culvert at Slk 6.74 requires specific consideration as the area prior to the culvert looks to be a suitable pull over area for road users, the culvert at this location is hazardous to road users if they proceed into the culvert.

Spencers Brook Road Slk 6.74 – Widened section prior to culvert

Recommendation

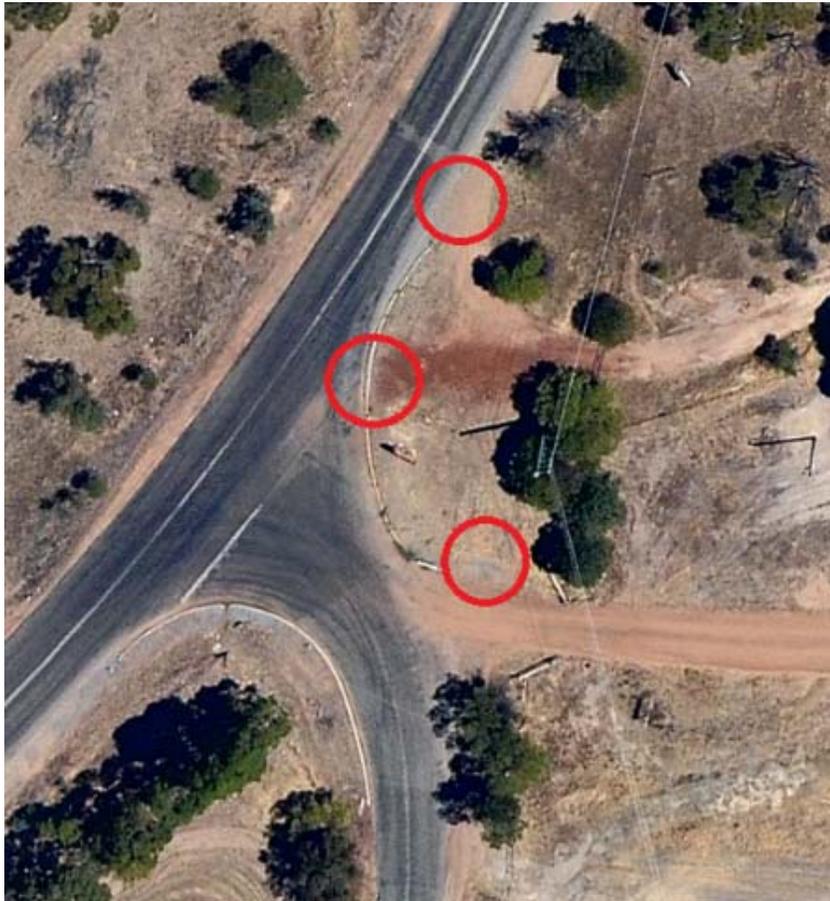
Property access at No. 705 appeared to have multiple access points which created additional conflict points, which have the potential to cause a collision between a road user, and property owner.

Barrier kerbing should not be used on high speed roads as it has the potential for vehicles to lose control, particularly motorcyclists, if struck.

The property access for No. 705 should be reassessed to ensure the location and driver behaviour does not encourage unsafe movements entering or exiting the road.

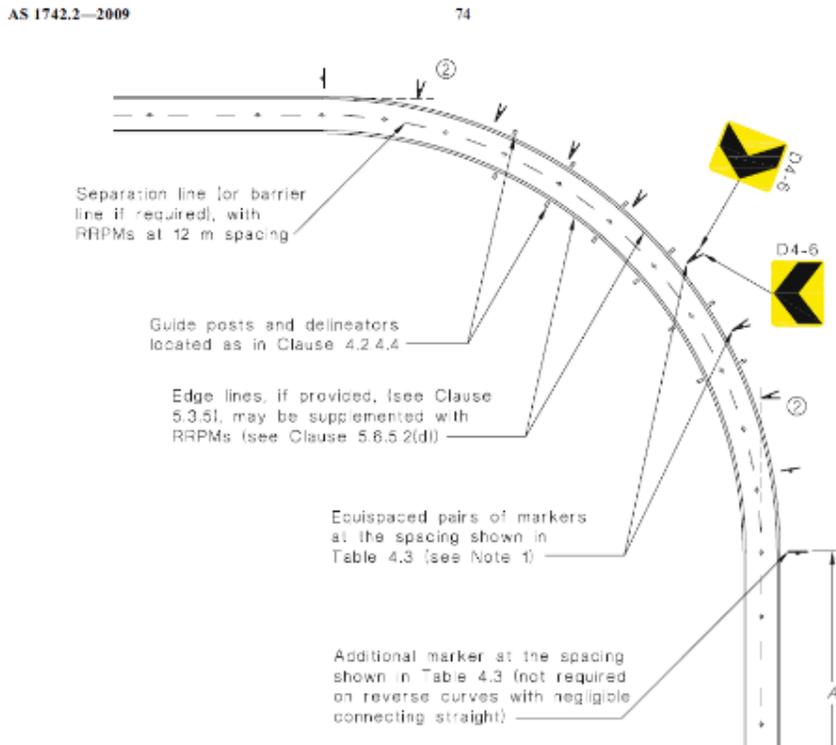
The correct Curved Alignment Markers are more prominent than the markers which are installed.

Install the correct Curved Alignment Markers in accordance with AS1742.2 and MRWA requirements.

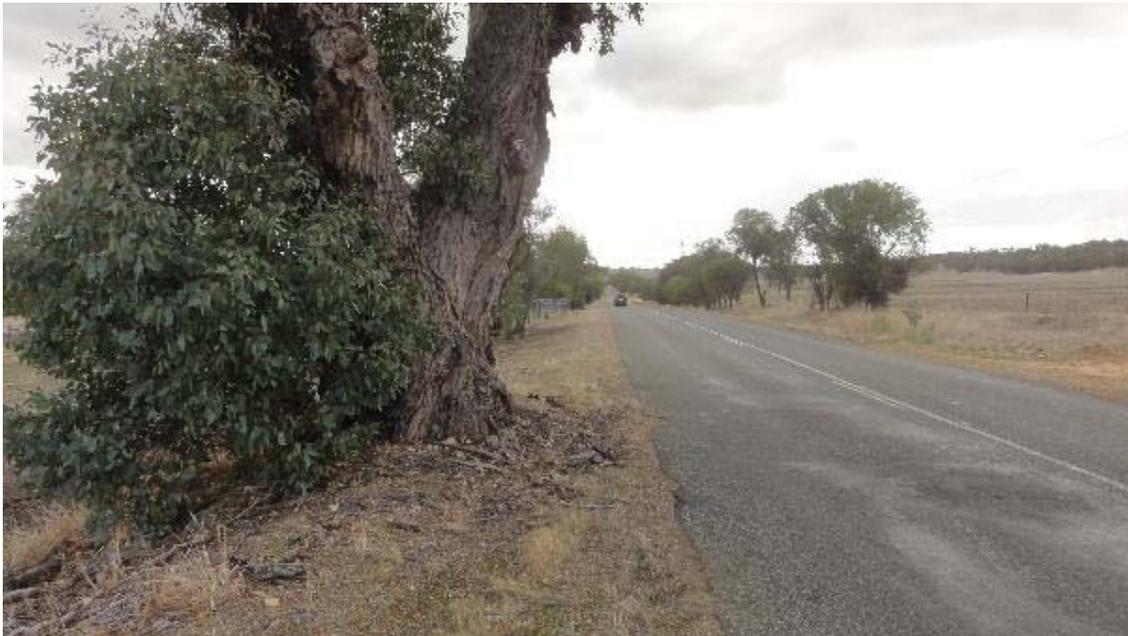
It was observed a number of non-frangible items were present along the road within the audit scope. These included power poles, non-frangible vegetation, culverts, and star pickets.

Items particularly noted included: Power poles at Slk 3.95, culvert at Slk 3.95 tree at Slk 6.09 (which is also resulting in damage to the road).

Finding 2.2 – Non Frangible items within clear zone

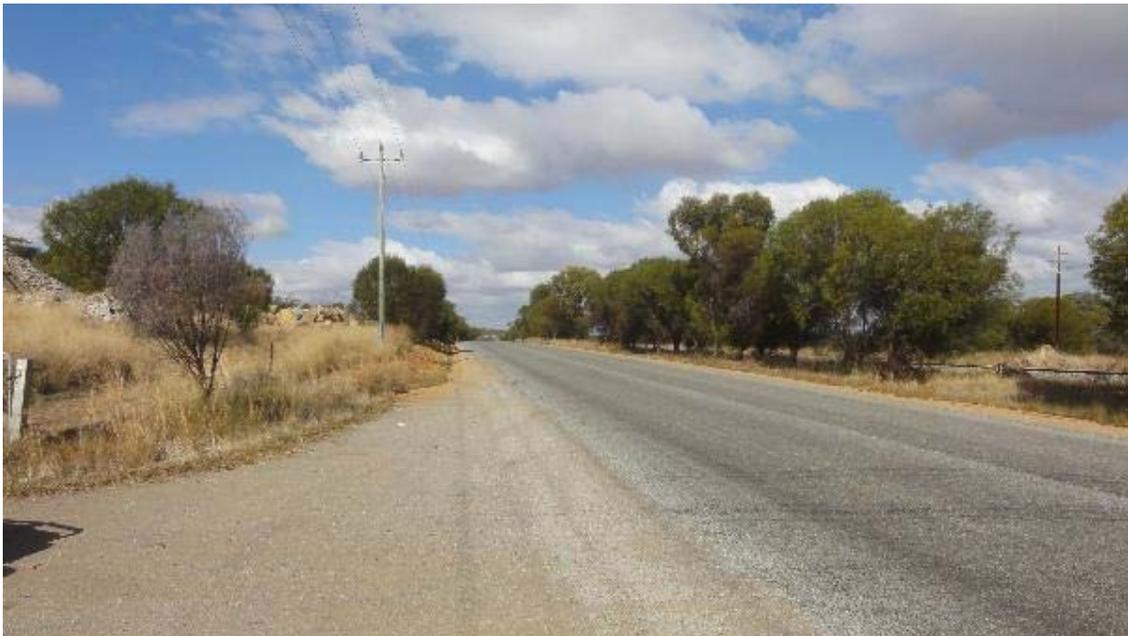
Main Roads WA 'Guide to Road Design – Driveways' recommends a 90 degree angle for driveways, but in special circumstances permits a minimum of 70 degrees. Failure to provide an appropriate exiting angle for vehicles reduces the available sight distance of vehicles approaching the driveway from the north (in this circumstance). Should a heavy vehicle driver fail to see a car on the approach a thru-left collision may occur.

Finding 2.4 – Quarry Access – Sight Distance to the south

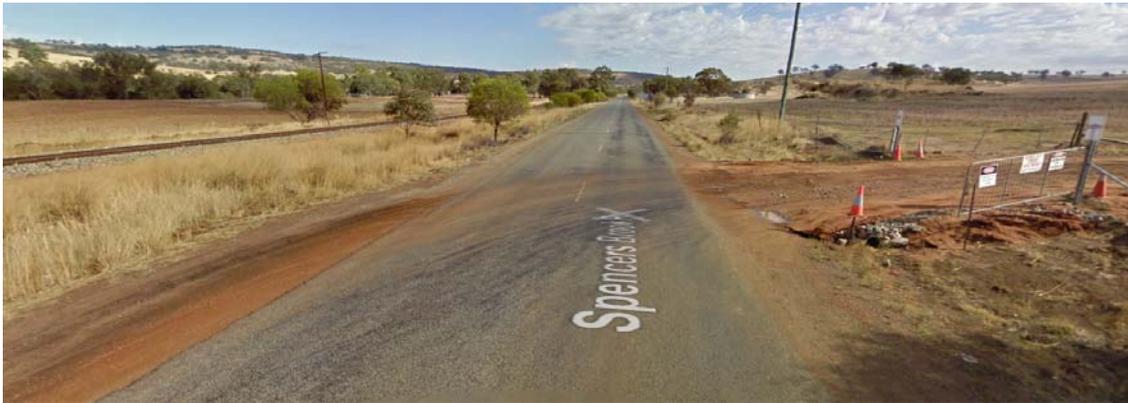
Heavy vehicles making manoeuvres from within the shoulder will likely result in damage to shoulder and the traffic lane edge. Frequent movements will result in ongoing maintenance and associated costs. Damage to the traffic lane edge may also result in damage to vehicles or loss of control should a vehicle drive onto a damaged surface.

Finding 2.4 – Quarry Access – Evidence (old) of large vehicles using shoulder

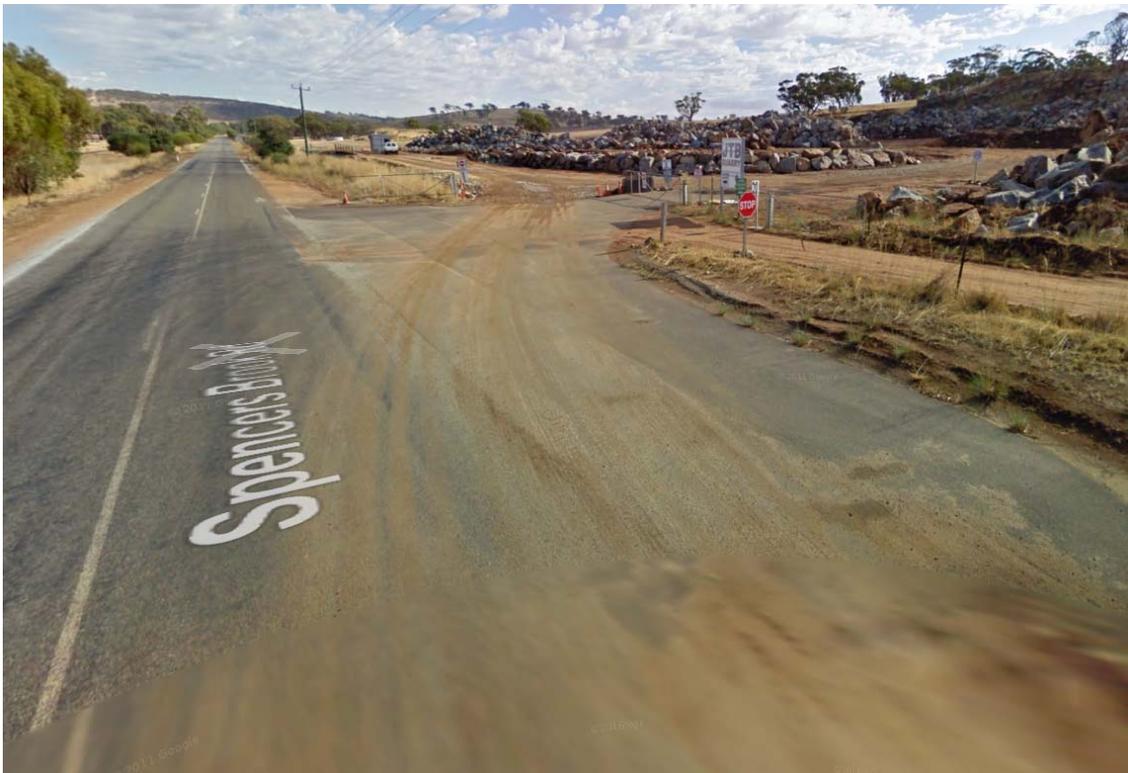
Finding 2.4 – Quarry Access – Evidence (old) of vehicles exiting the quarry

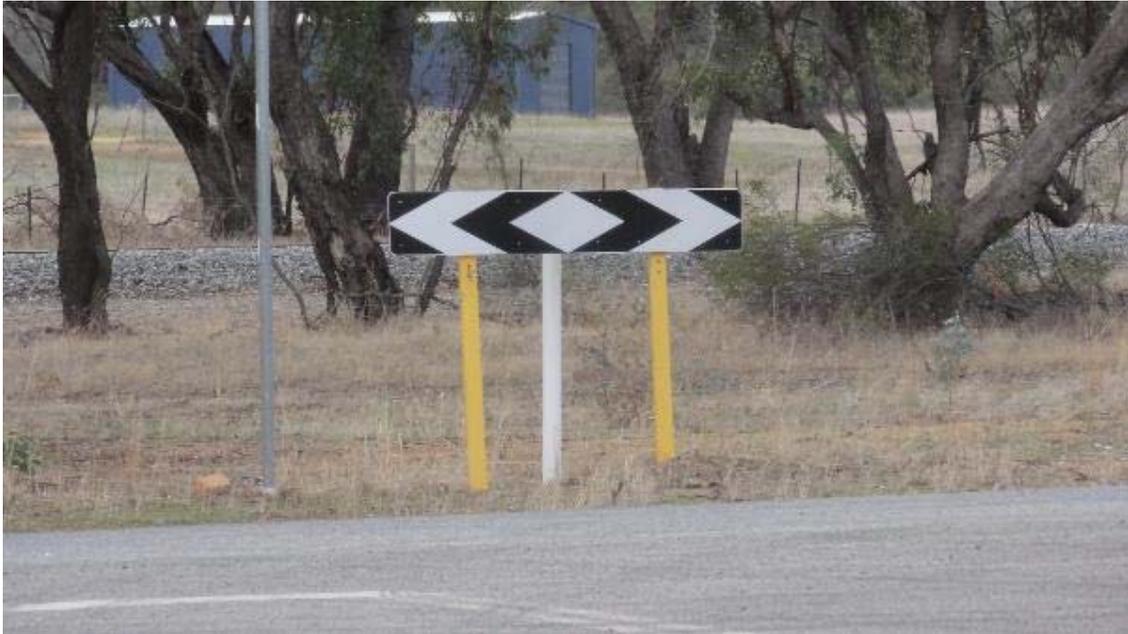
Finding 2.5 – Intersection warning signs –Example of incorrect sign used

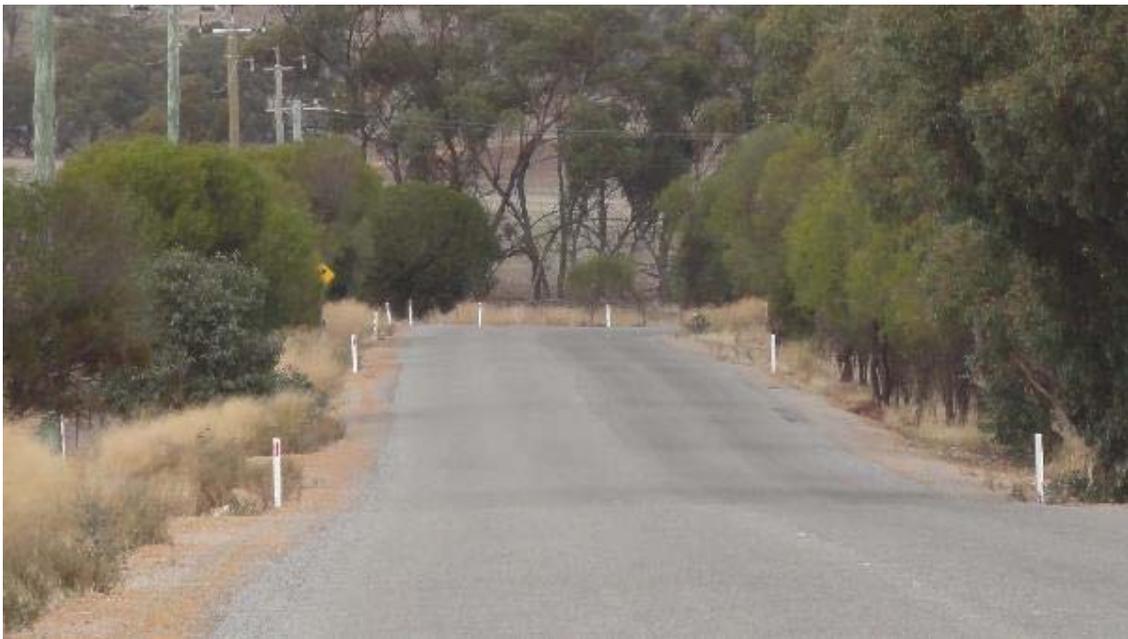
It was observed vegetation obstructed warning devices (signs and guideposts), sight distances, and hazards (ie culverts) along the road within the audit scope.

Warning devices along the route are only effective if they are visible to roads users. Should a warning device be obstructed by vegetation the road user does not receive the required information to proceed safely IE vegetation obstructing a curve warning sign. If guide posts are covered by vegetation this would impact on a drivers ability to determine the road alignment. Low level vegetation was also observed to restrict visibility of culverts at some of the locations, if a road user was to pull over into the shoulder, they may not see the culvert and proceed into the hazard.

Finding 2.6 – Vegetation Maintenance – Vegetation obstructing warning sign

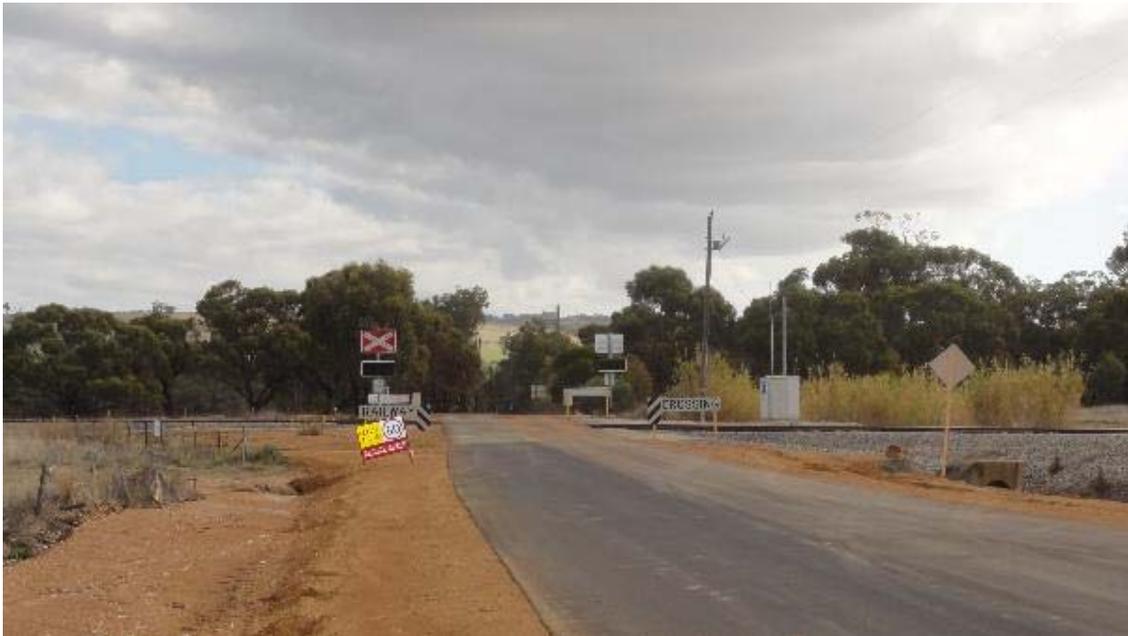
Recent works have resulted in pavement markings being removed or covered. Pavement markings were observed to be absent near the Quarry, and around Spencers Brook-York Road.

Finding 2.7 & 2.25 – Pavement markings missing removed from roadworks, and narrow approach seal 2.7m – Also note singled sided speed zone

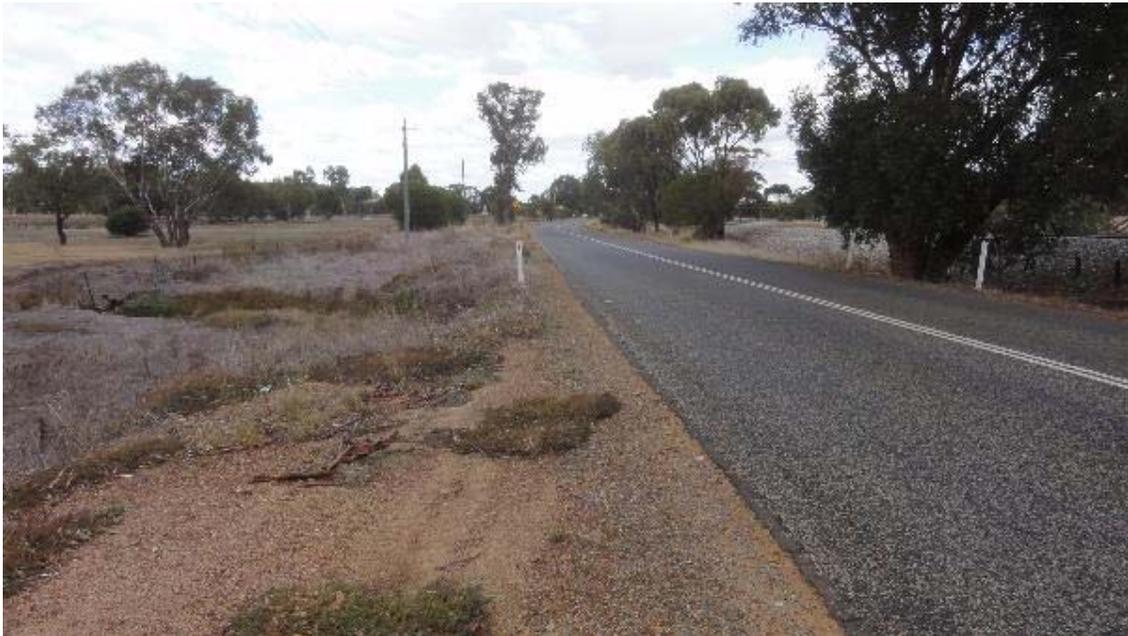
Finding 2.9 – Safety issues around culvert – Widened area prior to culvert

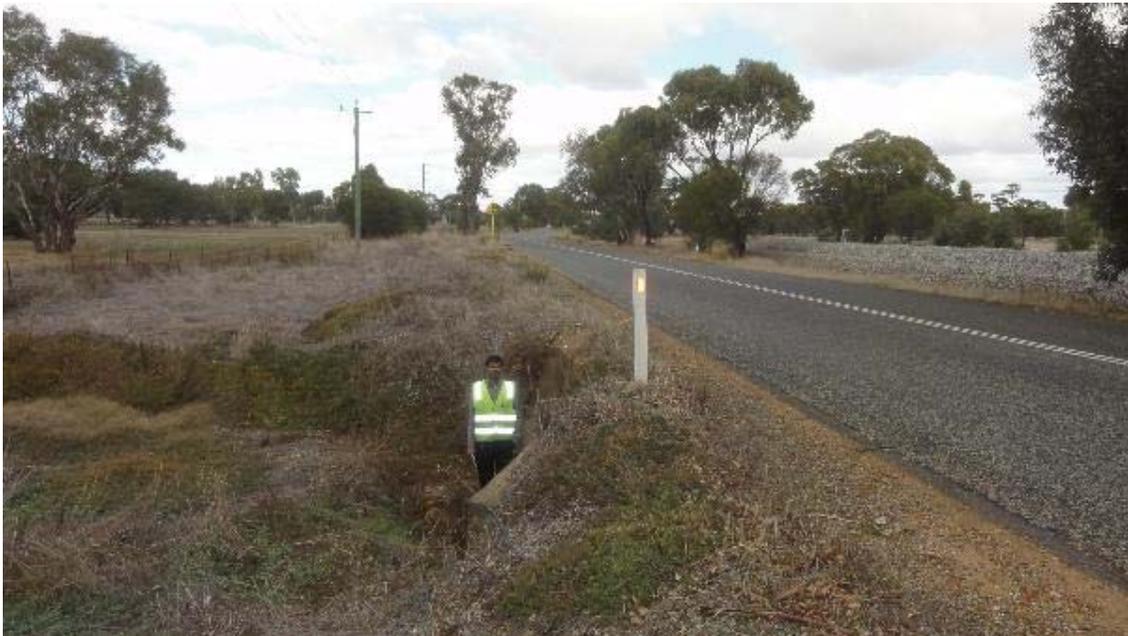
Culvert posts are recommended to mark the location of culvert headwalls. If a road user is not provided warning for the culvert then may inadvertently drive into the culvert if they pull over into the shoulder.

Finding 2.9 – Safety issues around culvert – Tall culvert within clear zone with no warning or protection other than a single guidepost (that is typical treatment of the road without culvert hazards)

Review the level of risk associated with culverts and consider treatments appropriate with the level of risk.

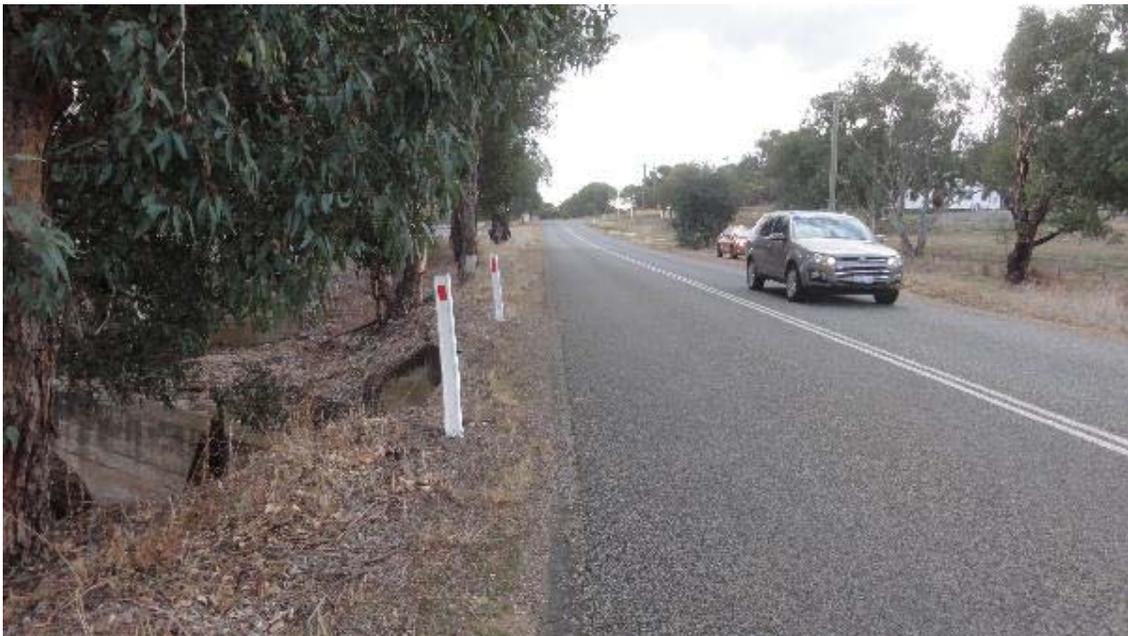
Finding 2.9 – Safety issues around culvert –Culvert within clear zone with no protection

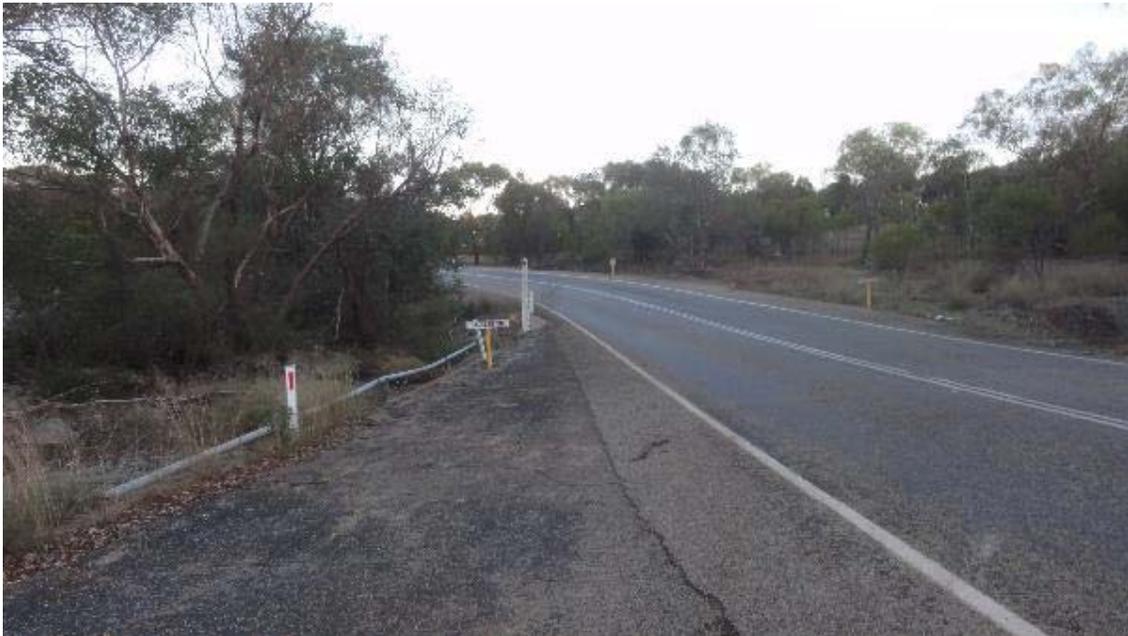
Finding 2.9 – Safety issues around culvert – Tall culvert within clear zone with no warning or protection

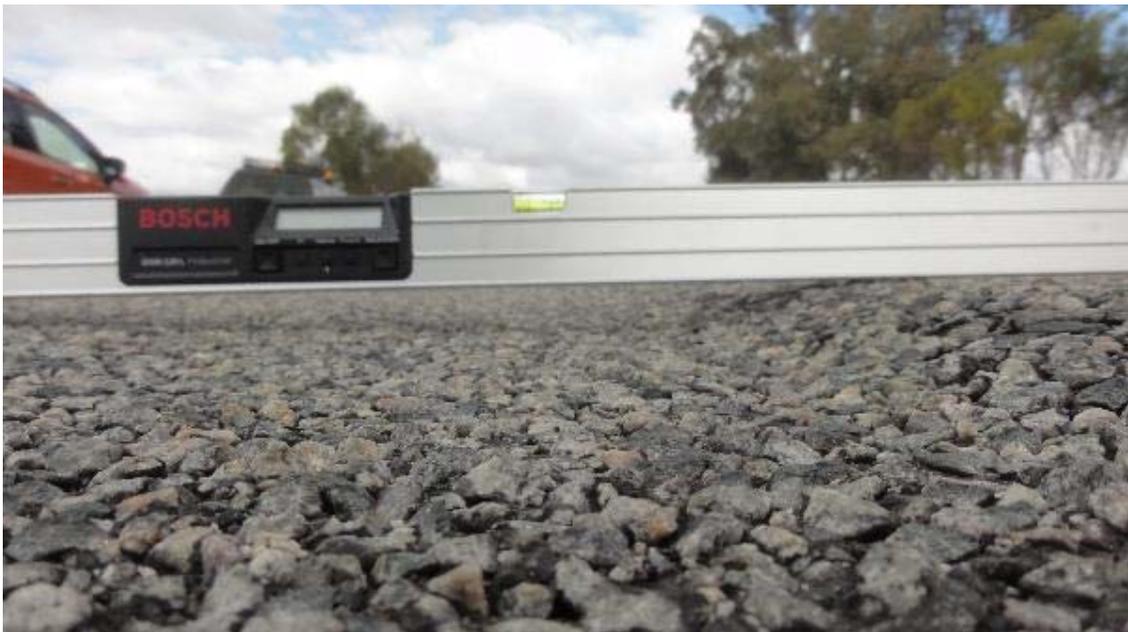
Road deformation was noted at two locations – Quarry access, and SLK 4.28.

Road defects can be hazardous to motorists, particularly motorcyclists as it may result in loss of control of the vehicle.

Finding 2.10 – Surface Condition – Road Deformation

Undertake repair works to remove any defects found along the road.

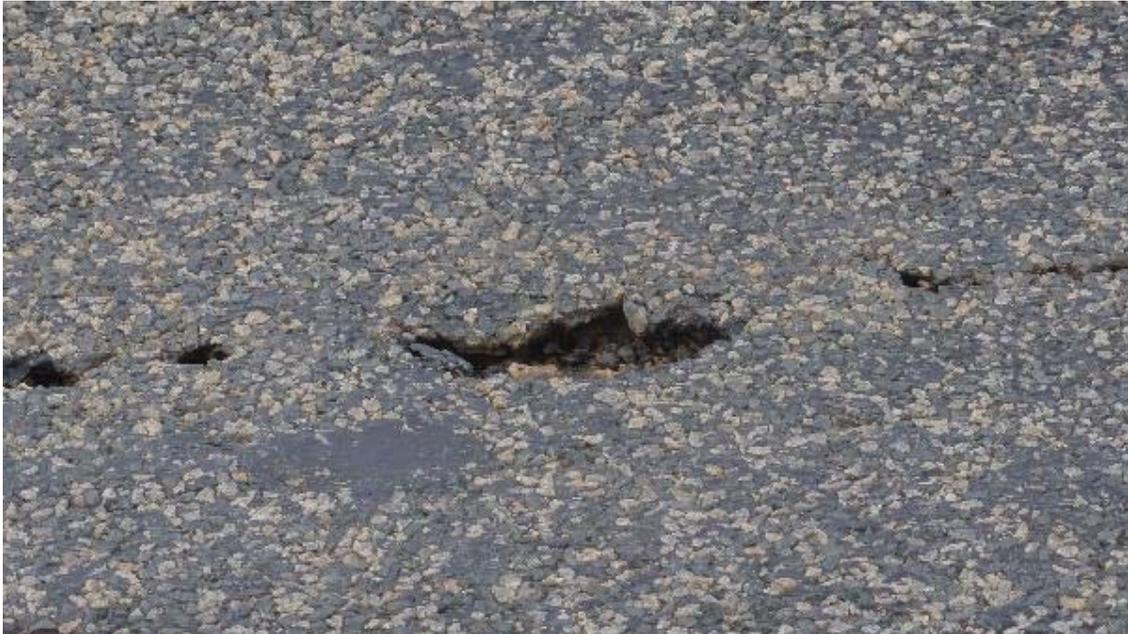
Multiple locations along the road within the audit scope had surface defects which included, pot holes, rutting, and road deformations.

Finding 2.10 – Surface Condition – Example of road damage

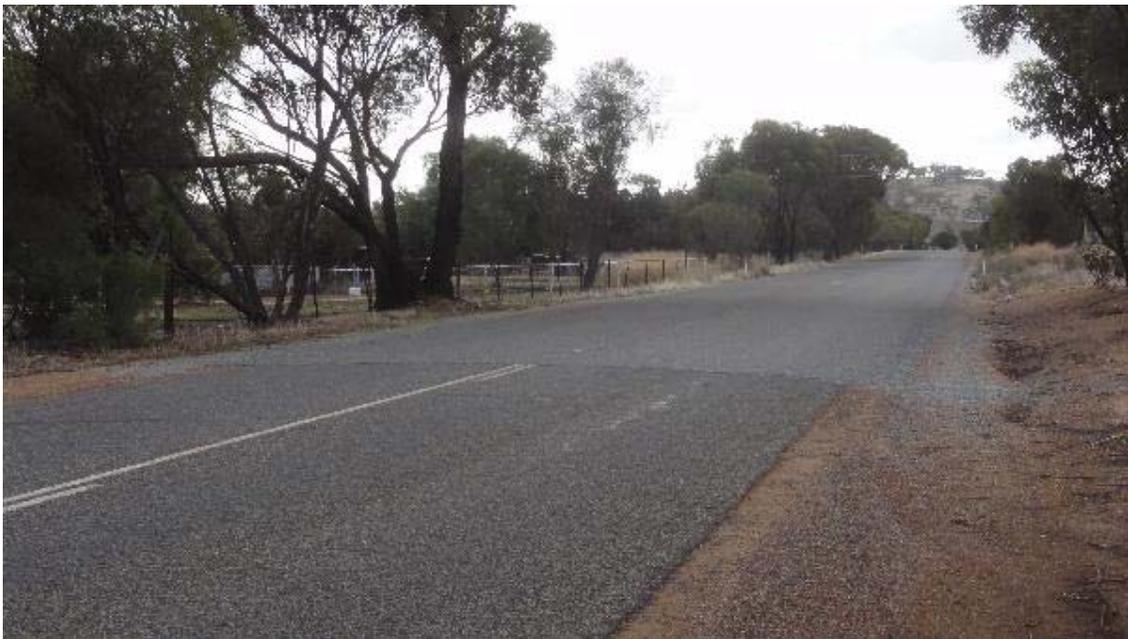
It was observed that recent works undertaken at SLK 5.42 widened the available road width, however a change in the road width between the newly widened section, and the old section exist.

Finding 2.11 – Sudden Road Width Change

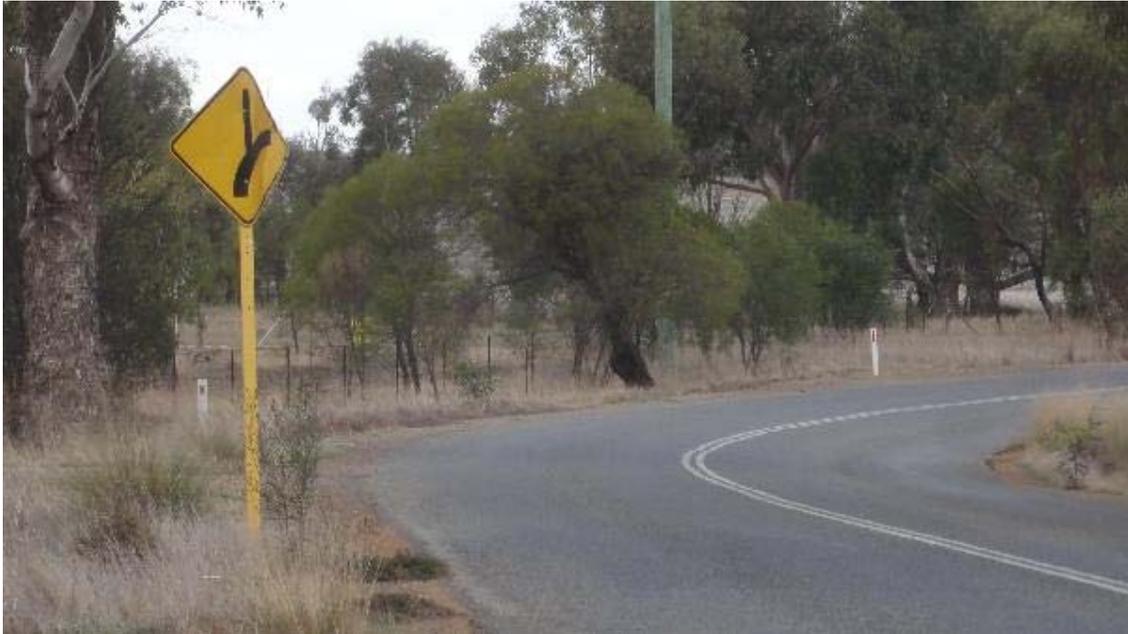
It was observed that damage has occurred to some warning devices along the road within the audit scope. These included guide posts, and warning signs. Those noted included but not limited to: guide posts around Slk 5.42, curve warning sign located at Slk 6.73.

Warning devices which are damaged no longer provide the required warning to the road user resulting in the road user unaware of the hazard for example the curve ahead.

Finding 2.12 – Damage to warning sign

Undertake remedial works to any damage warning devices

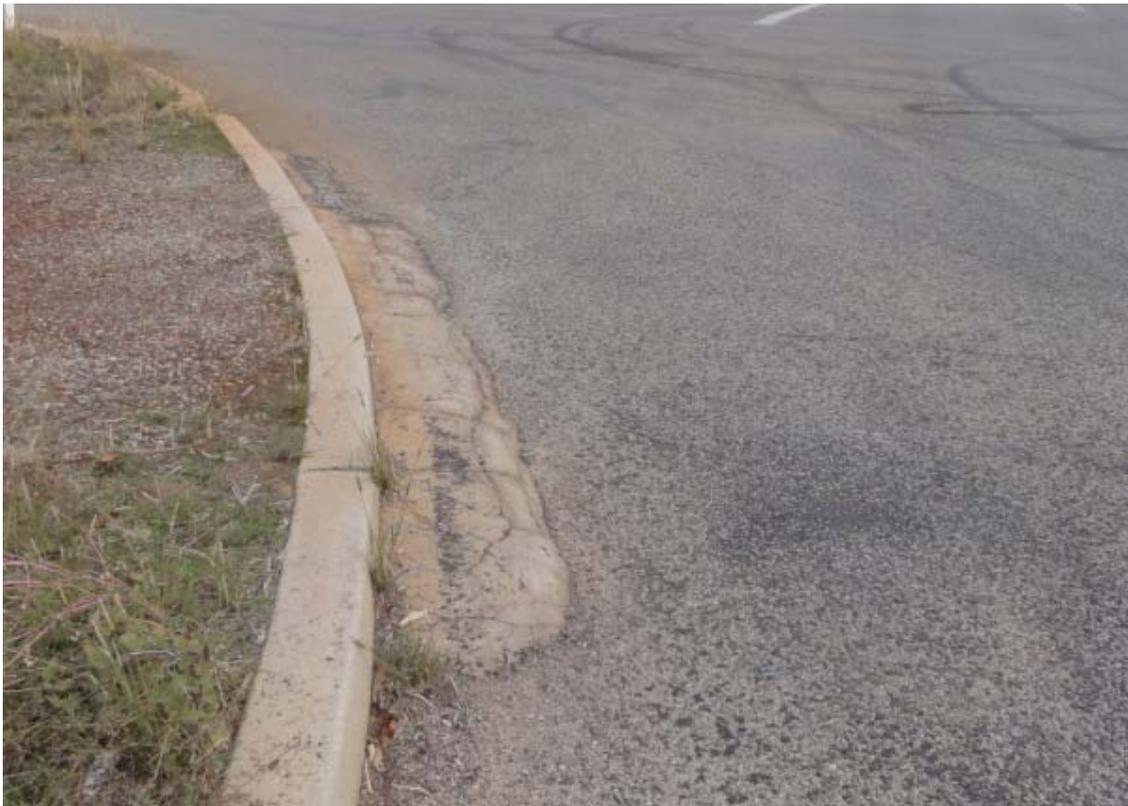
Finding 2.13 – Muresk Road intersection – Barrier kerbing used

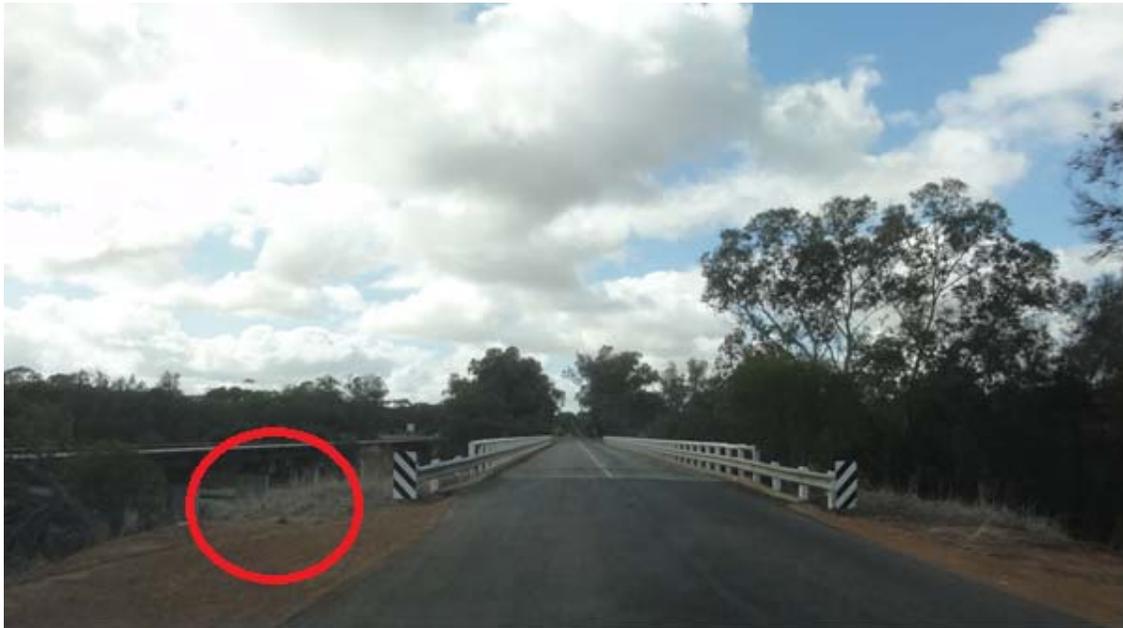
Significant injury to road users would be expected if the barrier system does not effectively manage an errant vehicle. Should the bridge not be suitable for the expected weight of vehicles, extensive structure damage would be expected.

Finding 2.14 – Bridges – Barrier system length would not provide protection of errant vehicle

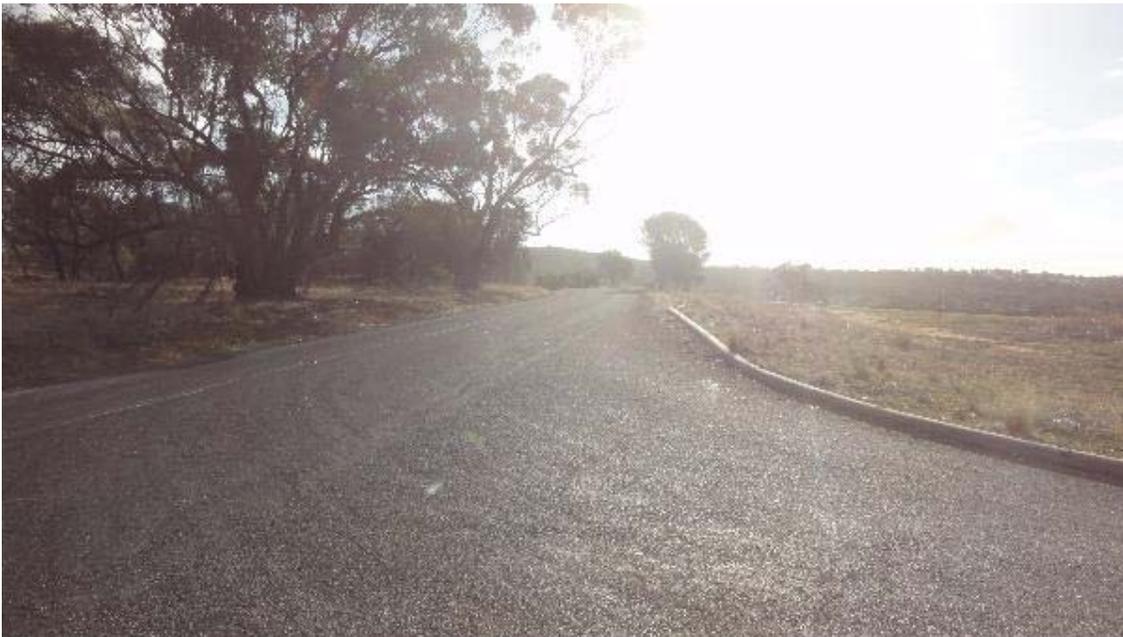
Multiple intersections within the audit scope failed to meet the minimum Safe Intersection Sight Distance (SISD). Vegetation appeared to be the main factor affecting sight distance. Trimmer Road was noted as having very poor sight distance.

Finding 2.15 – Intersection sight distance – Example of poor SISD (note sun glare in sunset conditions)

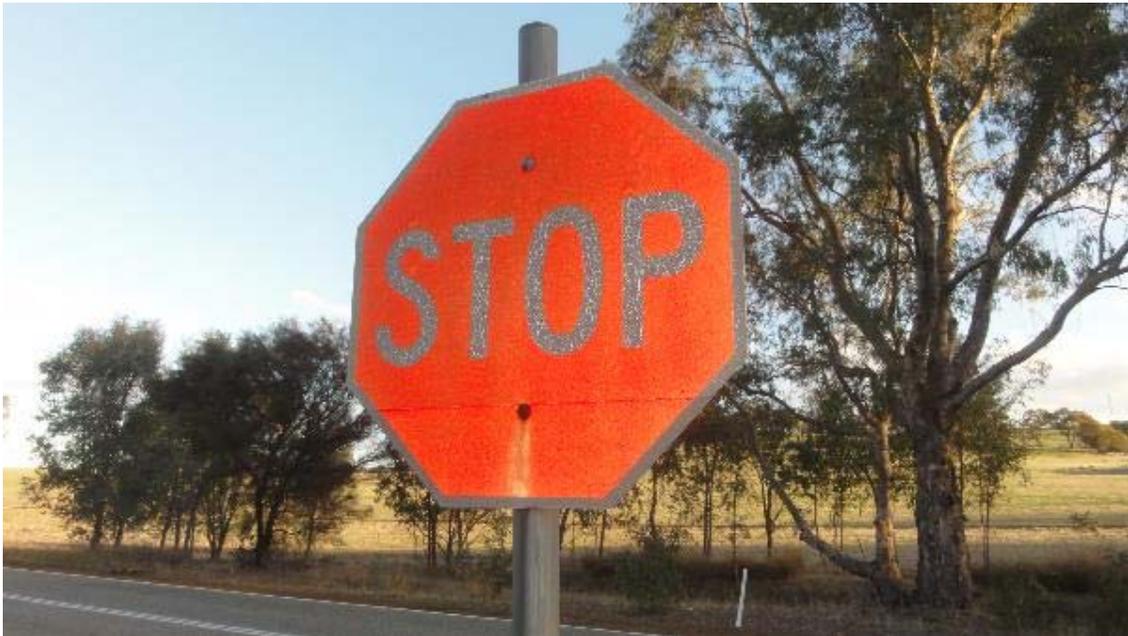
Along the road within the audit scope multiple signs had been observed to have substandard reflectivity or were in poor condition.

Signs/warning devices with substandard reflectivity or in poor condition may result in roads users not being able to read the sign and drive towards a hazard unaware, thereby increasing the risk to the road user.

Finding 2.16 – Sign and warning device sign condition

Undertake an audit on all signs to determine retro reflective compliance and condition, and replace all warning signs as required.

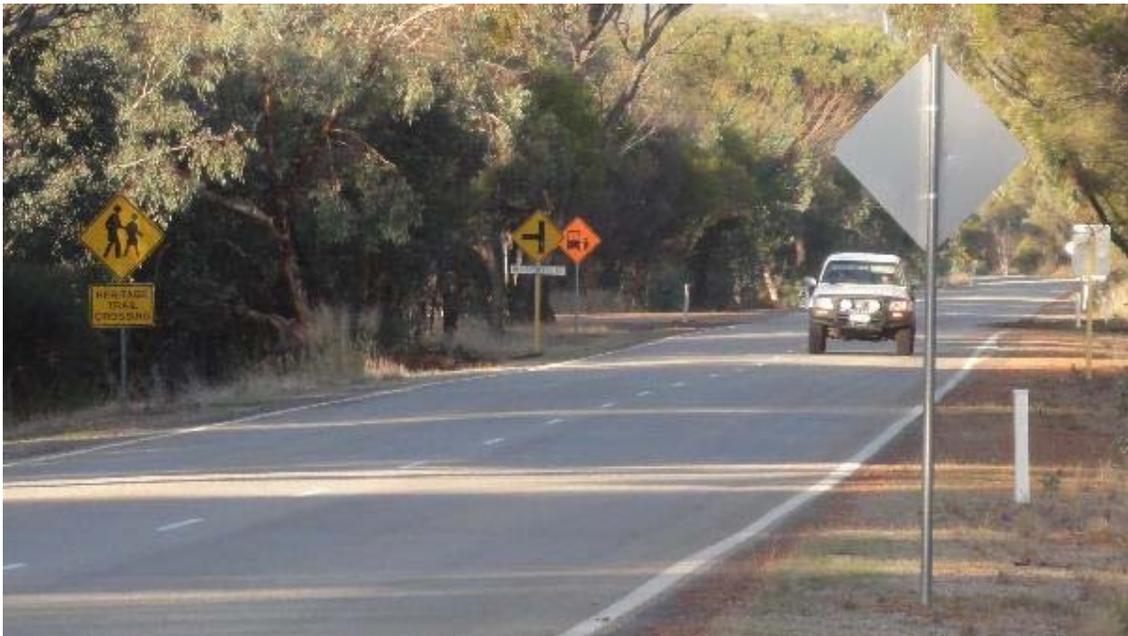
It was observed that 3 warning signs in advance of Old Spencer Road (Eastbound) where in close proximity to each other.

Finding 2.17 – Sign spacing

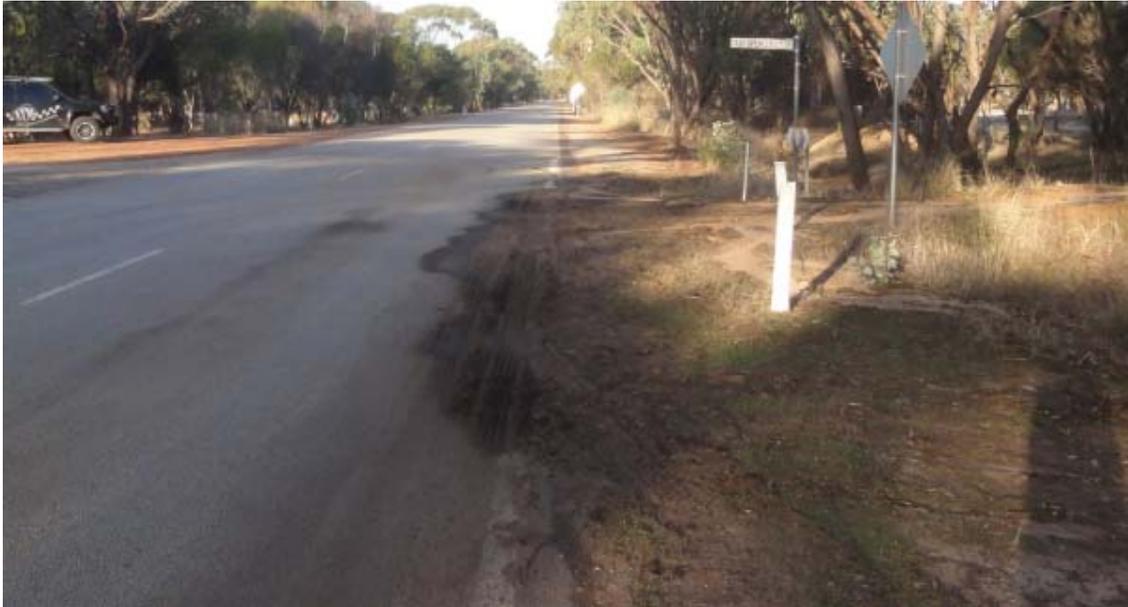
Finding 2.18 – Access Track – Debris on road

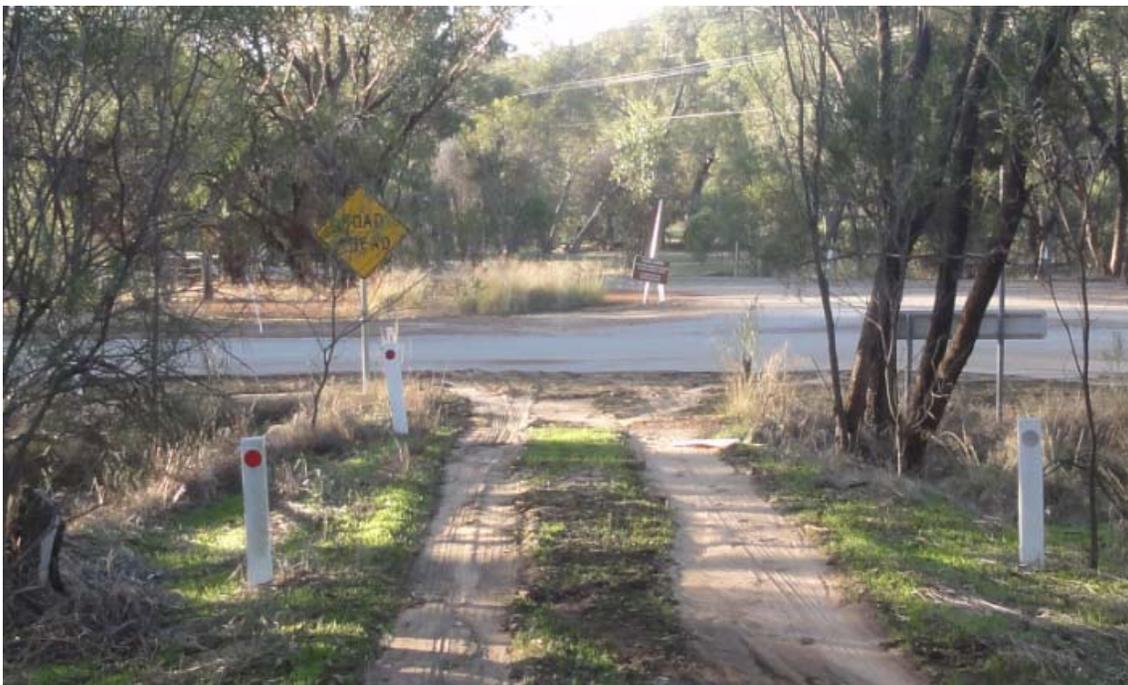
Finding 2.18 – Access Track – Used by vehicles

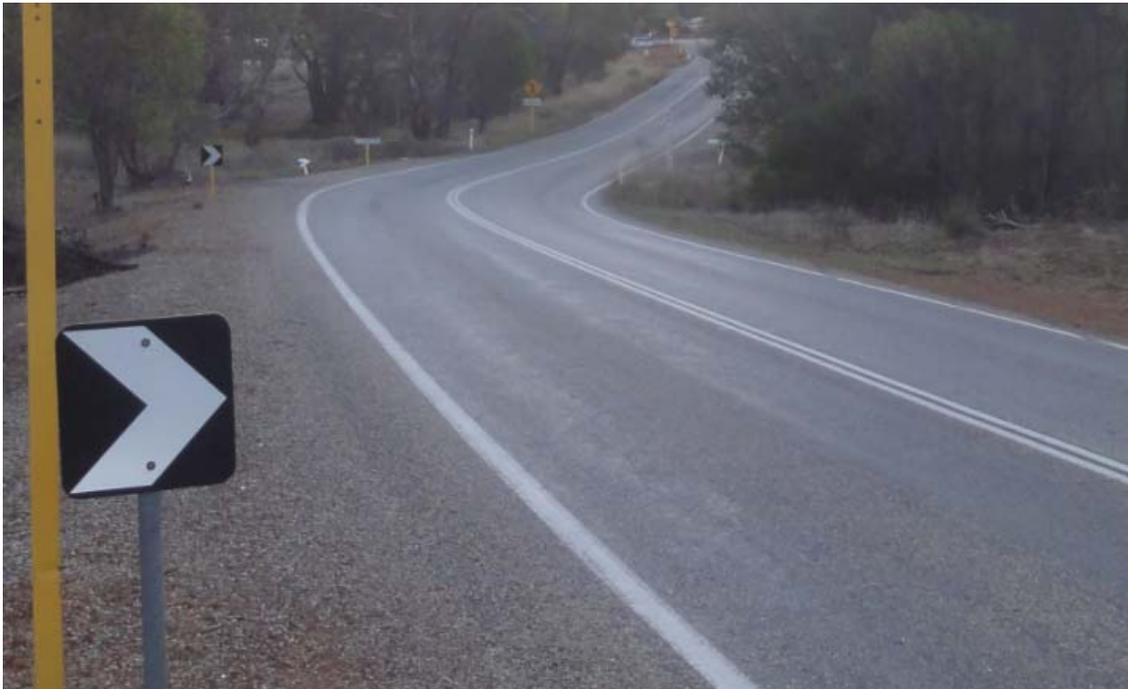
Finding 2.19 – Curved alignment markers – Incorrect and damaged signs present

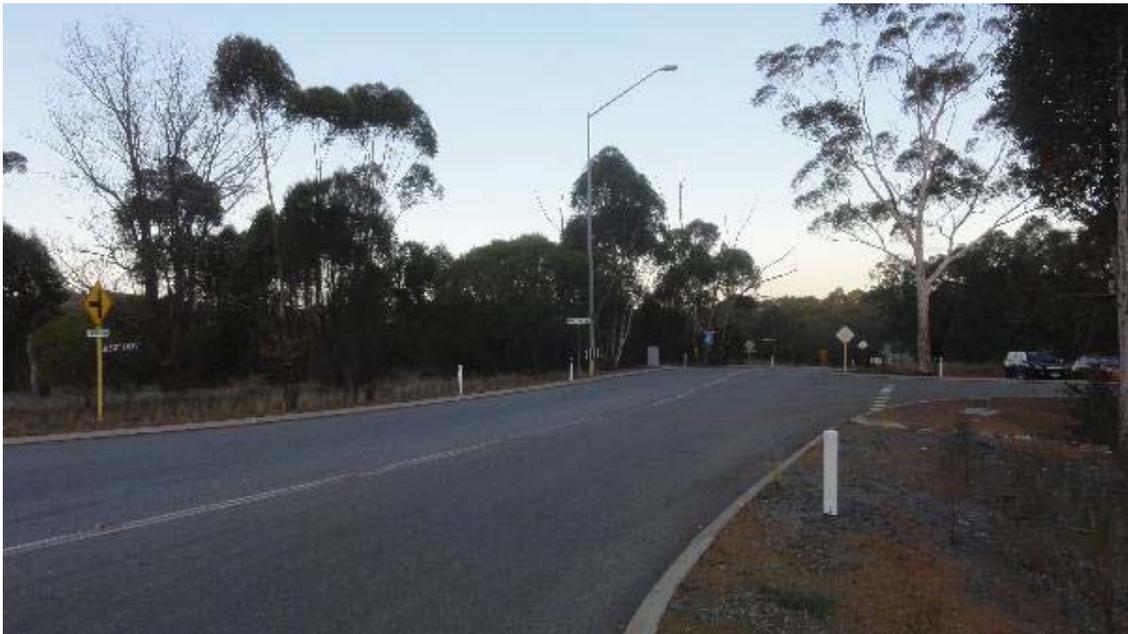
Finding 2.20 – Intersection warning sign for Lockyer Road and Eadine Road

Replace the current intersection warning sign with a sign which reflects the intersection.

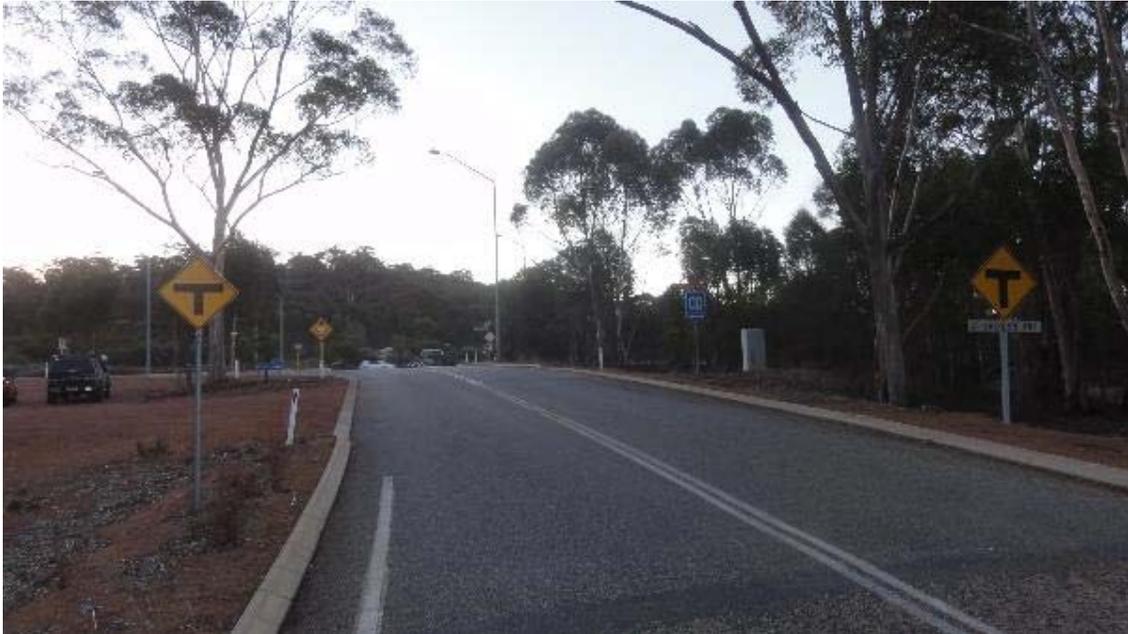
Finding 2.21 – Great Eastern Highway warning signs
