ROAD SAFETY INSPECTION

Spencers Brook Road Slk 3.26 –
23.87

Report Issue Date: **8/06/2018**

Revision 1

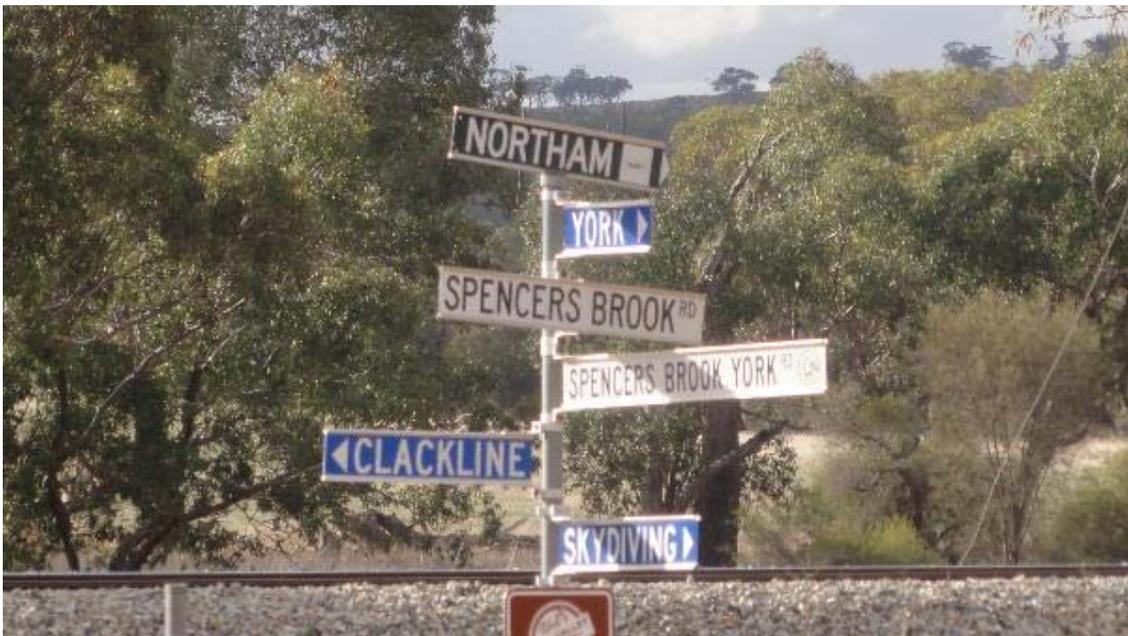
Finding 2.22 – Spencers Brook York Road Intersection Signs
