ST. JOSEPH'S SCHOOL

ALTERATIONS & ADDITIONS - STAGE 14

Heritage Impact Statement

GEOTECHNICAL STUDY PROPOSED ADDITIONS ST JOSEPH'S SCHOOL – SECONDARY CAMPUS 77 WELLINGTON STREET, NORTHAM

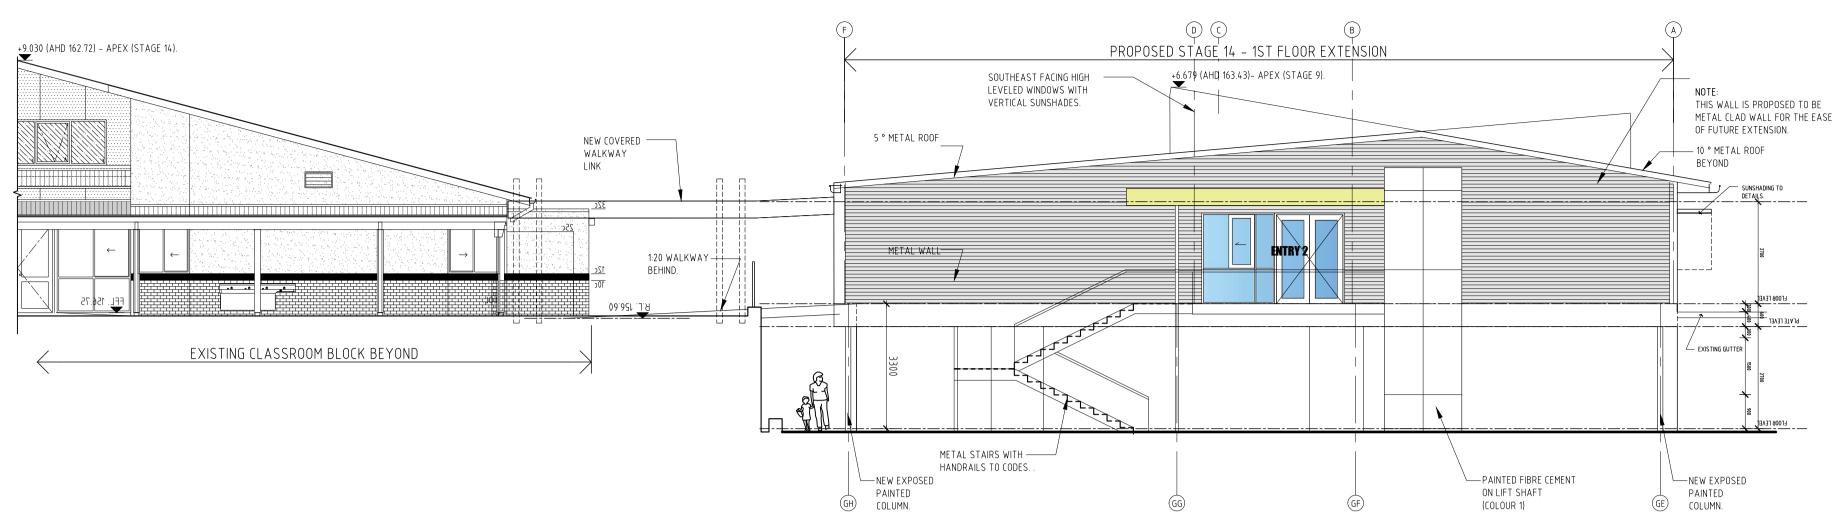
PORTION 'A' - FIRST FLOOR EXTENSION PROPOSED ELEVATION 3 - NORTH EAST SCALE 1:100 @A1

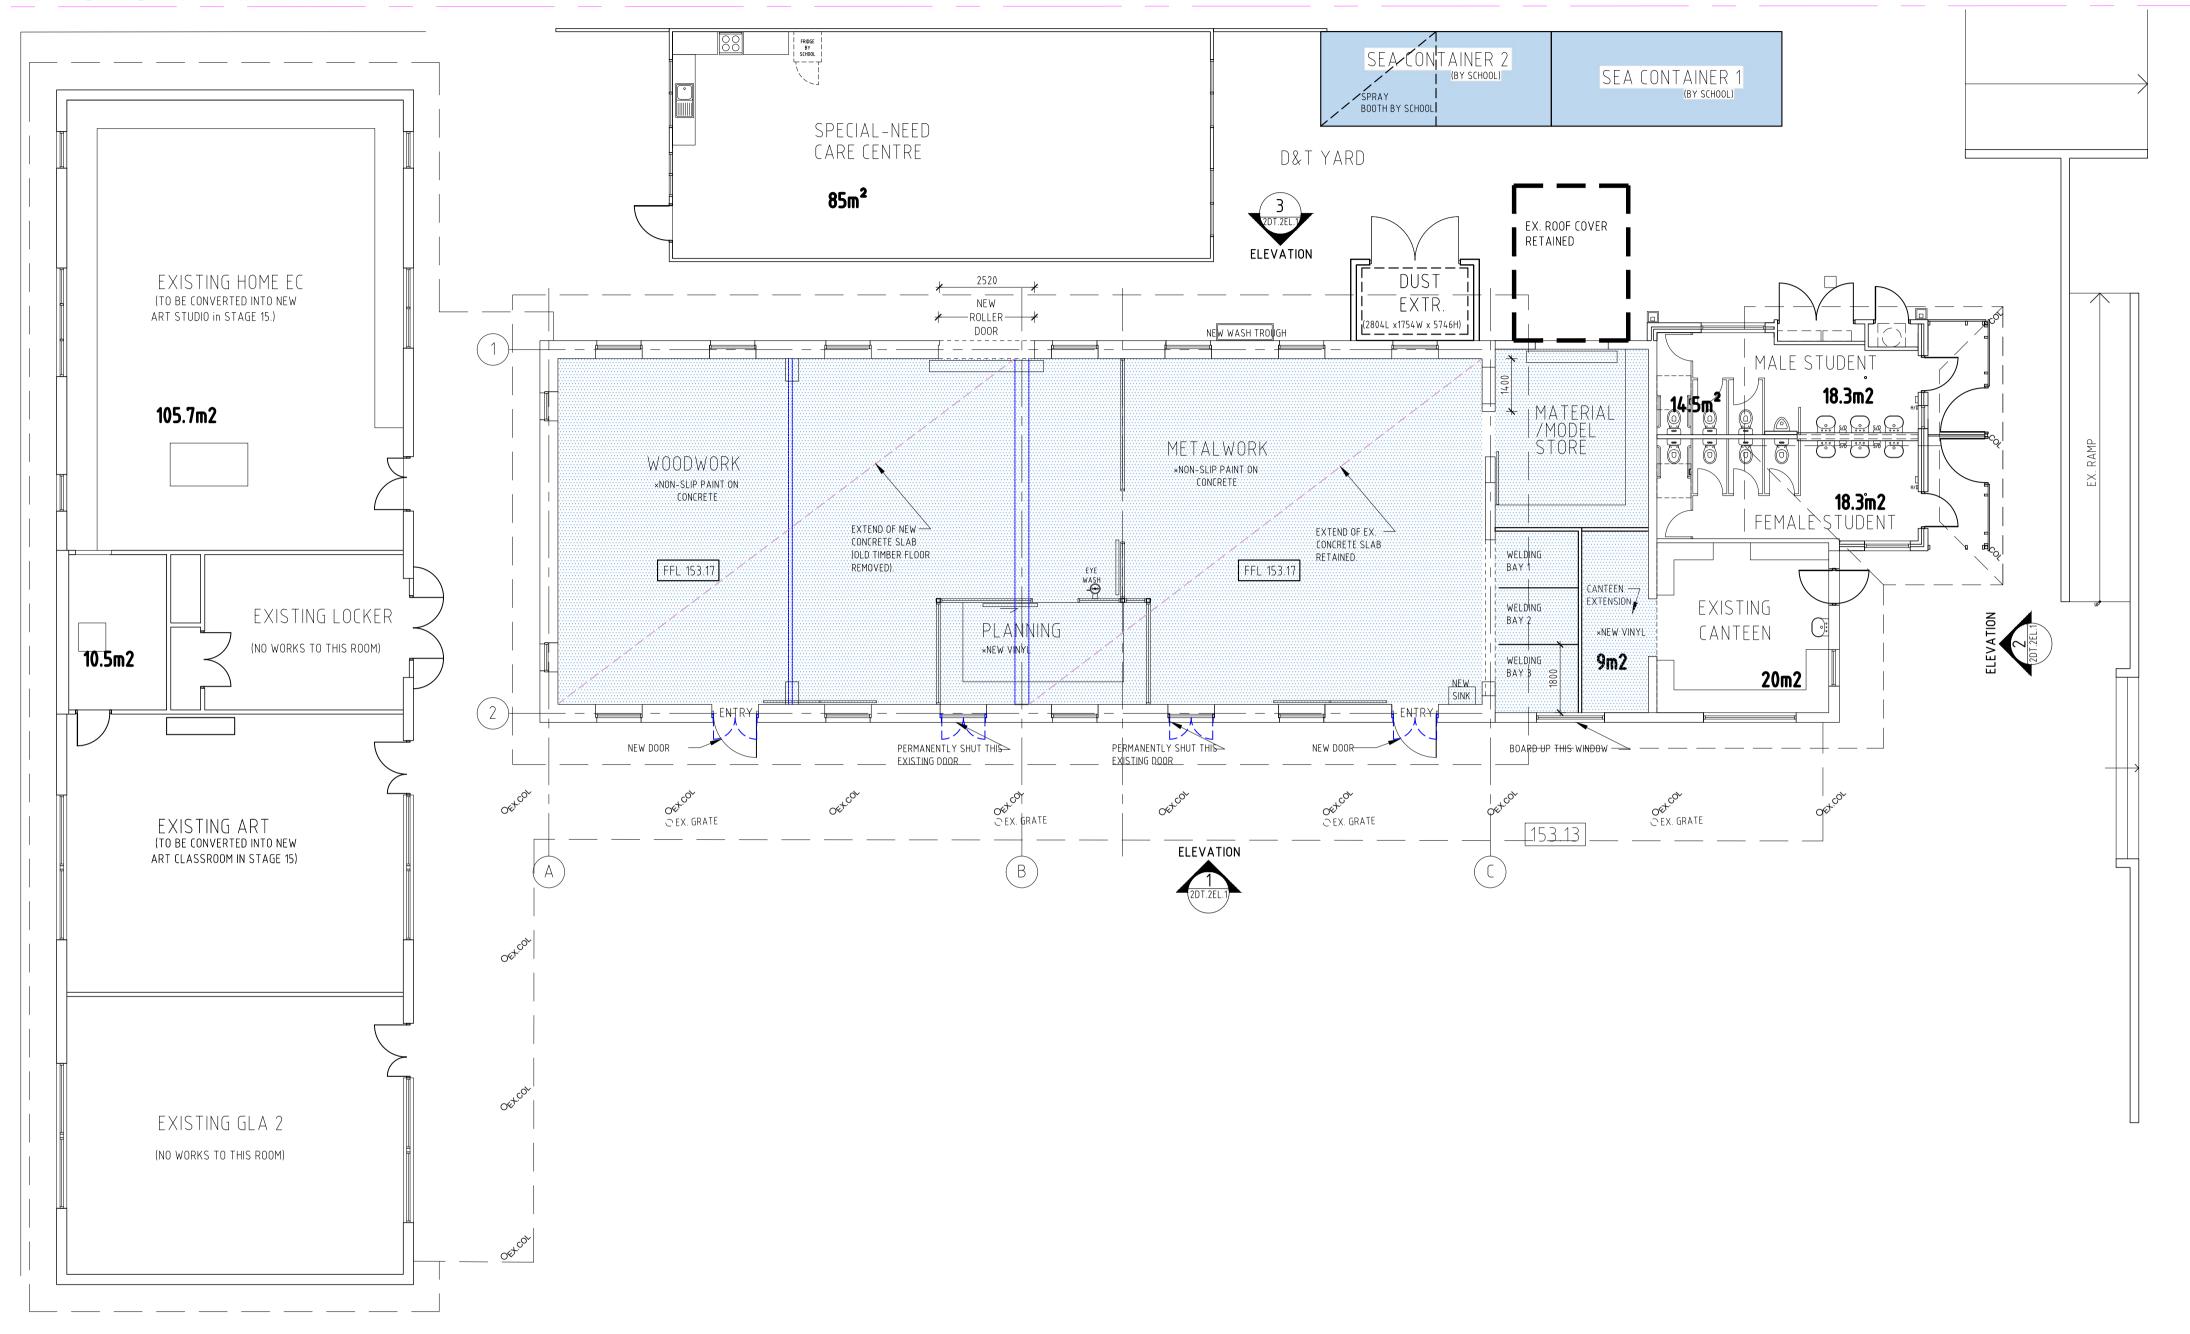
PORTION 'B' - D & T PROPOSED FLOOR PLAN

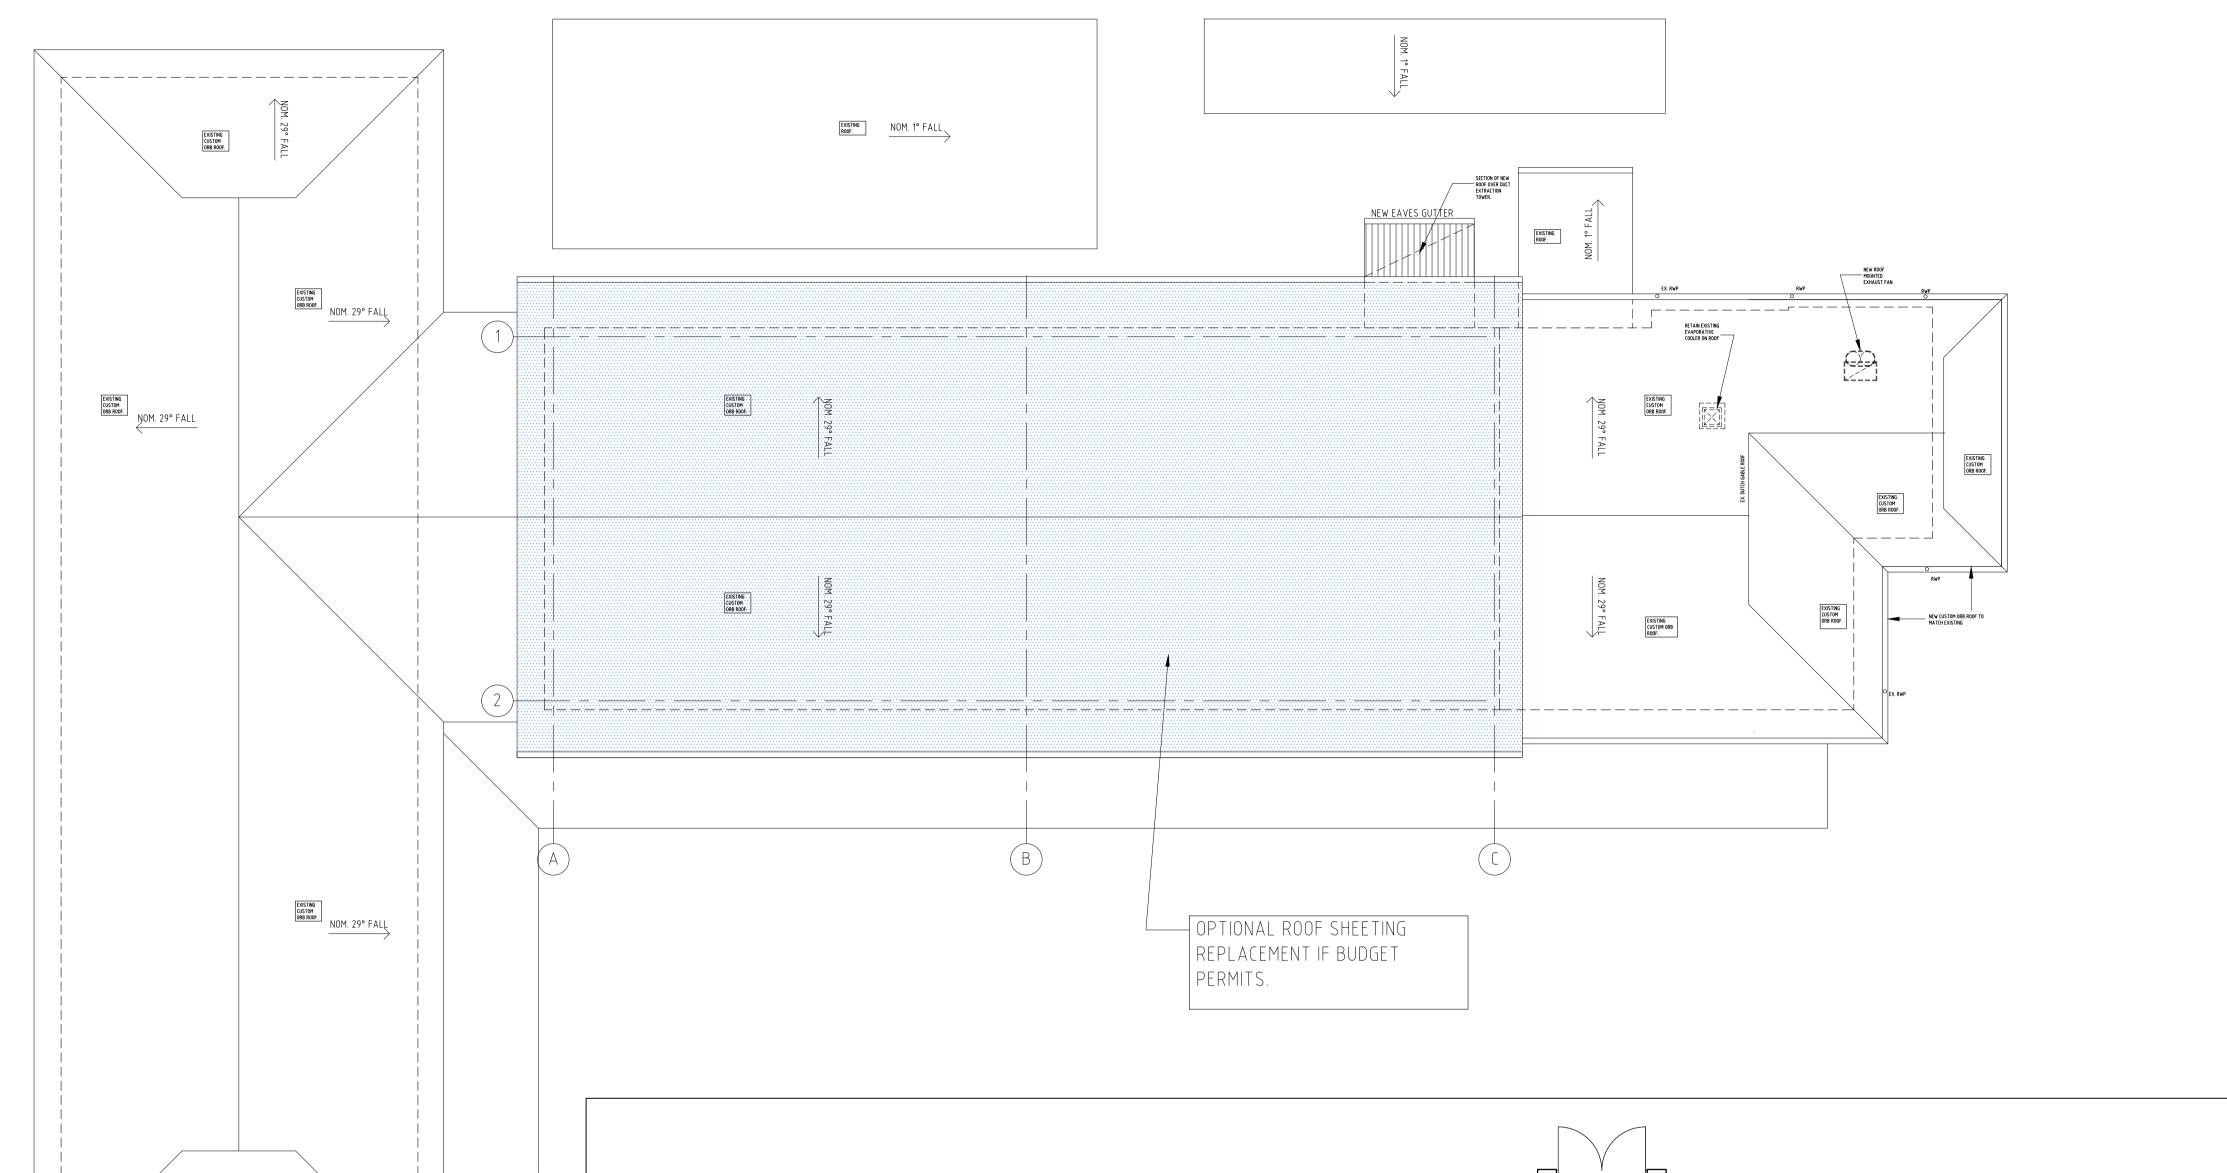
PORTION 'B' - D&T PROPOSED ROOF PLAN

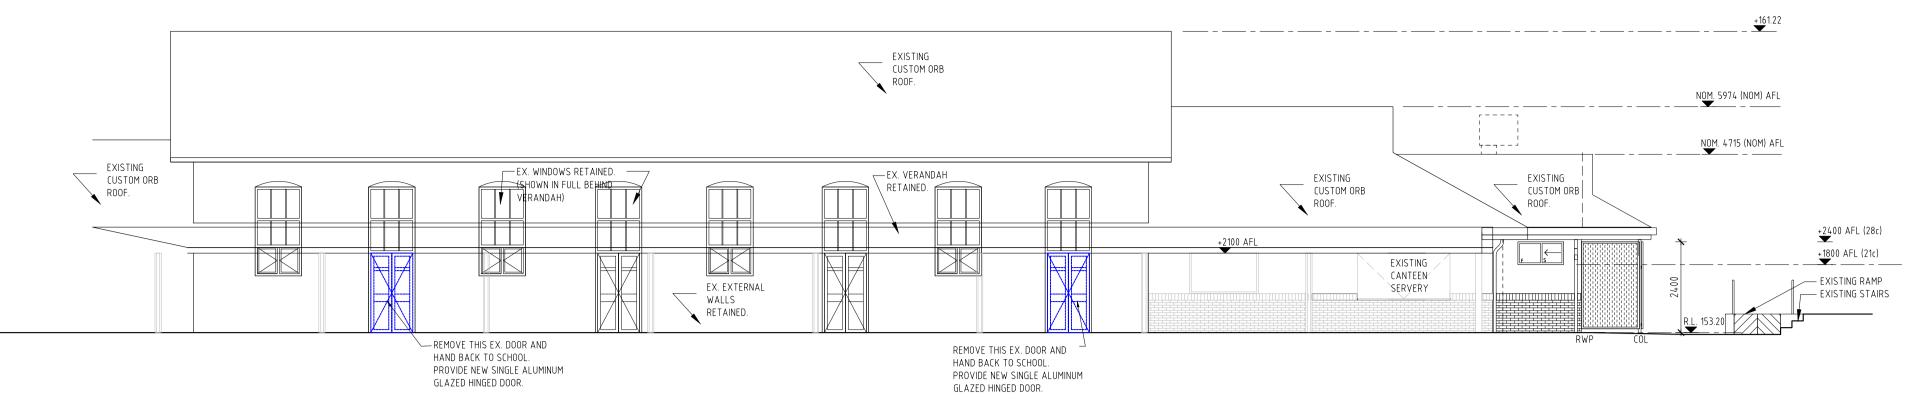
EXISTING D & T BUILDING ELEVATION 1 - SOUTH WEST

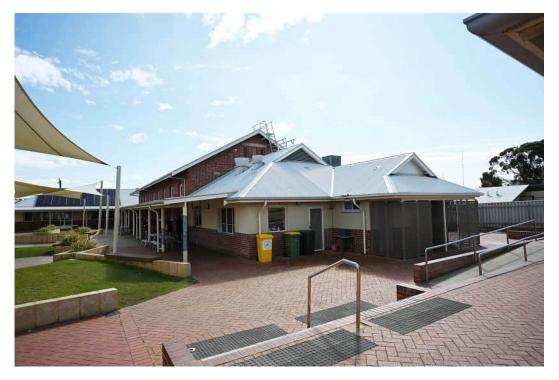
Photograph 3 Southern corner of D&T building. Canteen in foreground. *Griffiths Architects Aug 2024*

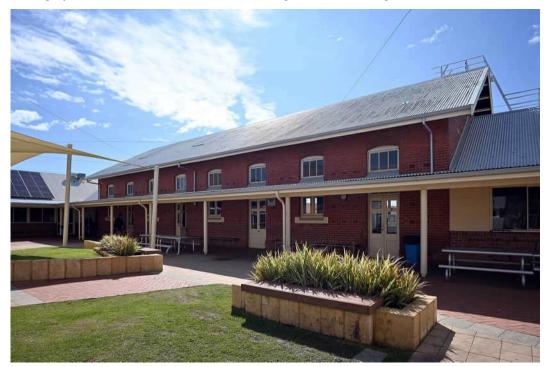
Photograph 4 D&T south elevation. Note awning cutting across openings. *Griffiths Architects Aug 2024*

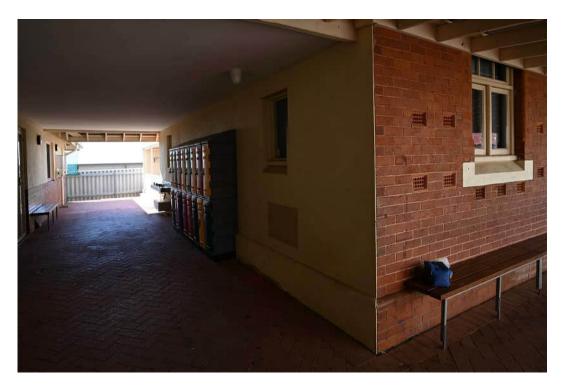
Photograph 5 Western corner of D&T building under awning. Note awning cutting across openings. Art and Home Economics building to the left. *Griffiths Architects Aug 2024*

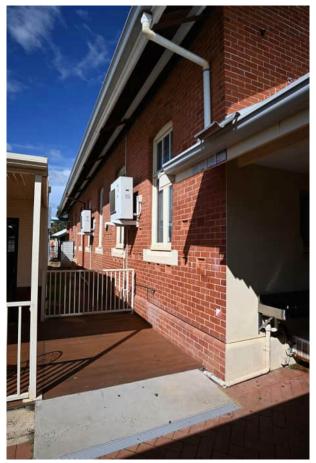
Photograph 6

Northern corner of D&T building under awning. Transportable classroom to the left. *Griffiths Architects Aug 2024*

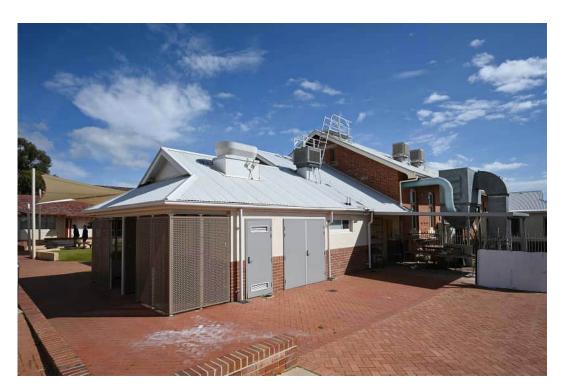
Photograph 7 Eastern corner of D&T building with toilets in foreground and mechanical exhaust in the background to the right. *Griffiths Architects Aug 2024*

Mechanical services and a transportable classroom have been added to the north side of the building.

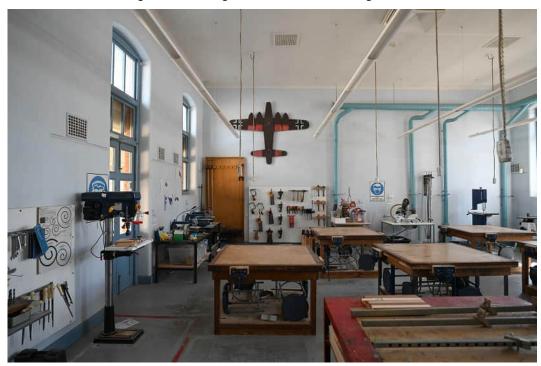
Photograph 8 North western view within machinery room. Dividing wall in background to be removed as part of the works. *Griffiths Architects Aug 2024*

Internally original timber floorboards remain insitu in the computer classroom and GLA 1. However they have been replaced with concrete in the machinery room. Dividing walls have been installed to create three rooms which are currently used for machinery and computing classrooms respectively. Modern machinery and suspended lighting have been installed. Former windows on the east elevation have been removed and converted into doorways. An internal fixed pane window has been installed adjacent the northern doorway. High level plasterboard ceilings have been installed previously covering the original raked timber ceilings which remain insitu. Evaporative mechanical services have been installed within the ceiling space. Mechanical exhausts have been installed to the north east section of roof.

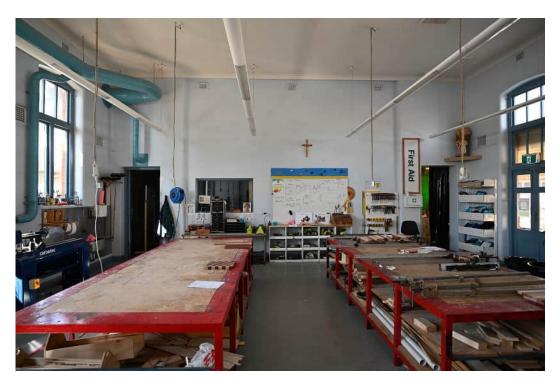
Photograph 9 South eastern view within machinery room. Openings to either side of wall are alterations of original window openings. *Griffiths Architects Aug 2024*

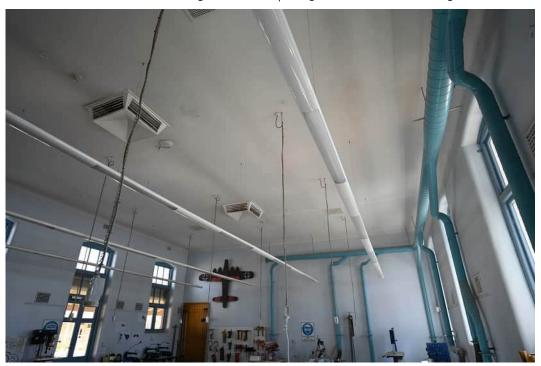
Photograph 10 View of replacement plaster glass ceiling concealing original timber raked ceiling . *Griffiths Architects Aug 2024*

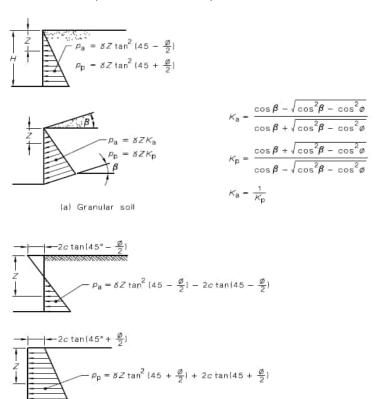
Inline Image 1 – Passive and Active Loads (from AS4678-2002)

The effective strength parameters should be used for analysis of free-draining granular soils and the long-term stability of clayey soils. The formulae for active and passive pressures are shown below for cohesionless soil and cohesive soil¹.

Retaining walls must be designed to accommodate full hydrostatic water pressure behind the wall (10 kPa per metre height). In this instance, calculation of lateral earth pressures must include the addition of pore pressure. A separator

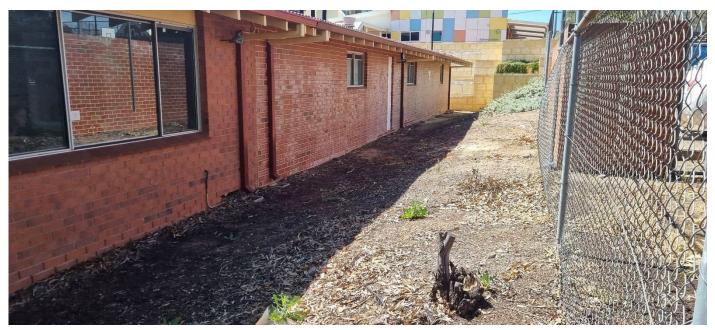
Photograph 6: Facing east to south-west face of building; note downpipes discharging into small square drainage boxes

The most likely cause of the inundation is the limited capacity of the open box drains to collect and discharge stormwater flows into the buried 100 mm nominal PCV stormwater drain pipe aligned parallel to the building. This situation is likely to be exacerbated by clogging of the box drains with leaf matter.
